PRACTICAL SENSITIVITY LIMITS OF PRODUCTION  
NONDESTRUCTIVE TESTING METHODS IN ALUMINUM  
AND STEEL

Boeing Commercial Airplane Company

Air Force Materials Laboratory

AFML-TR-74-241

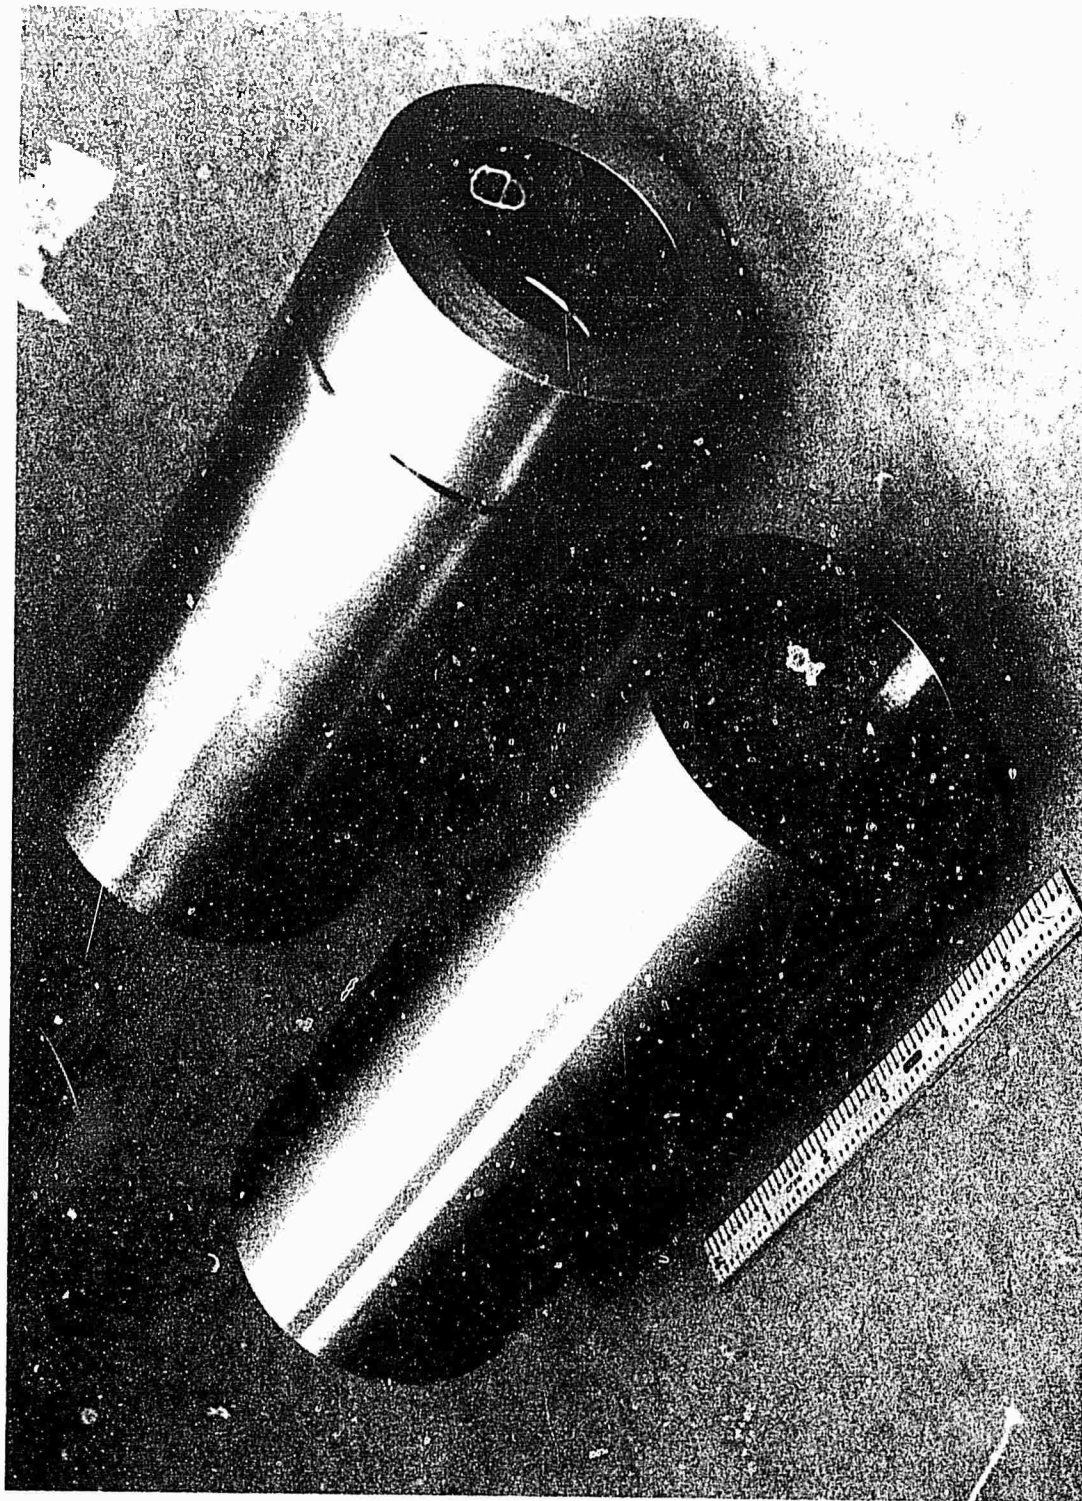
*Figure 17.—Straight Hollow Cylinder Specimen and Blank*

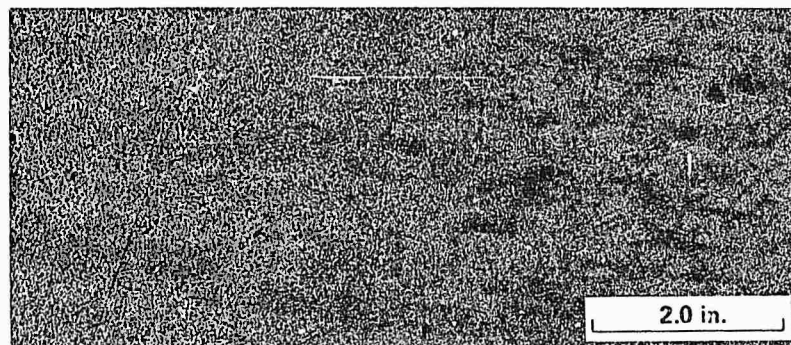
a. Fluorescent Magnetic Particle Indications of Grinding Cracks in Specimen SN-5 (0.5X)

b. Surface Shown in a After Etching to Reveal Nonuniform Metallurgical Structure (0.5X)

c. Recordings of Eddy Current Response Obtained from Scans Above and Below Centerline of Specimen
